4. TITLE (and Subtitle) National Program of Inspection of Non-Federal Dams, Tennessee. Coon Creek Dam (Inventory Number TN 04508) near Lenox, Tennessee, Dyer County, TN., Obion River Basin.		5. TYPE OF REPORT & PERIOD COVERED Phase I Investigation Report

This report is based on the findings of the Phase I investigation of OFDBA Site #60-6 on February 4, 1981. This study was done in accordance with "Recommended Guidelines for Safety Inspection of Dams", Office of the Chief of Engineers.

The earth dam is 54 feet high and 726 feet long with a crest width of 25 feet. At normal pool the dam impounds a 125 acre lake (2137 acre-feet) used for flood control. It is in the intermediate size and high hazard potential category. The downstream slope is 2.6H:1V and the upstream slope is 3H:1V.

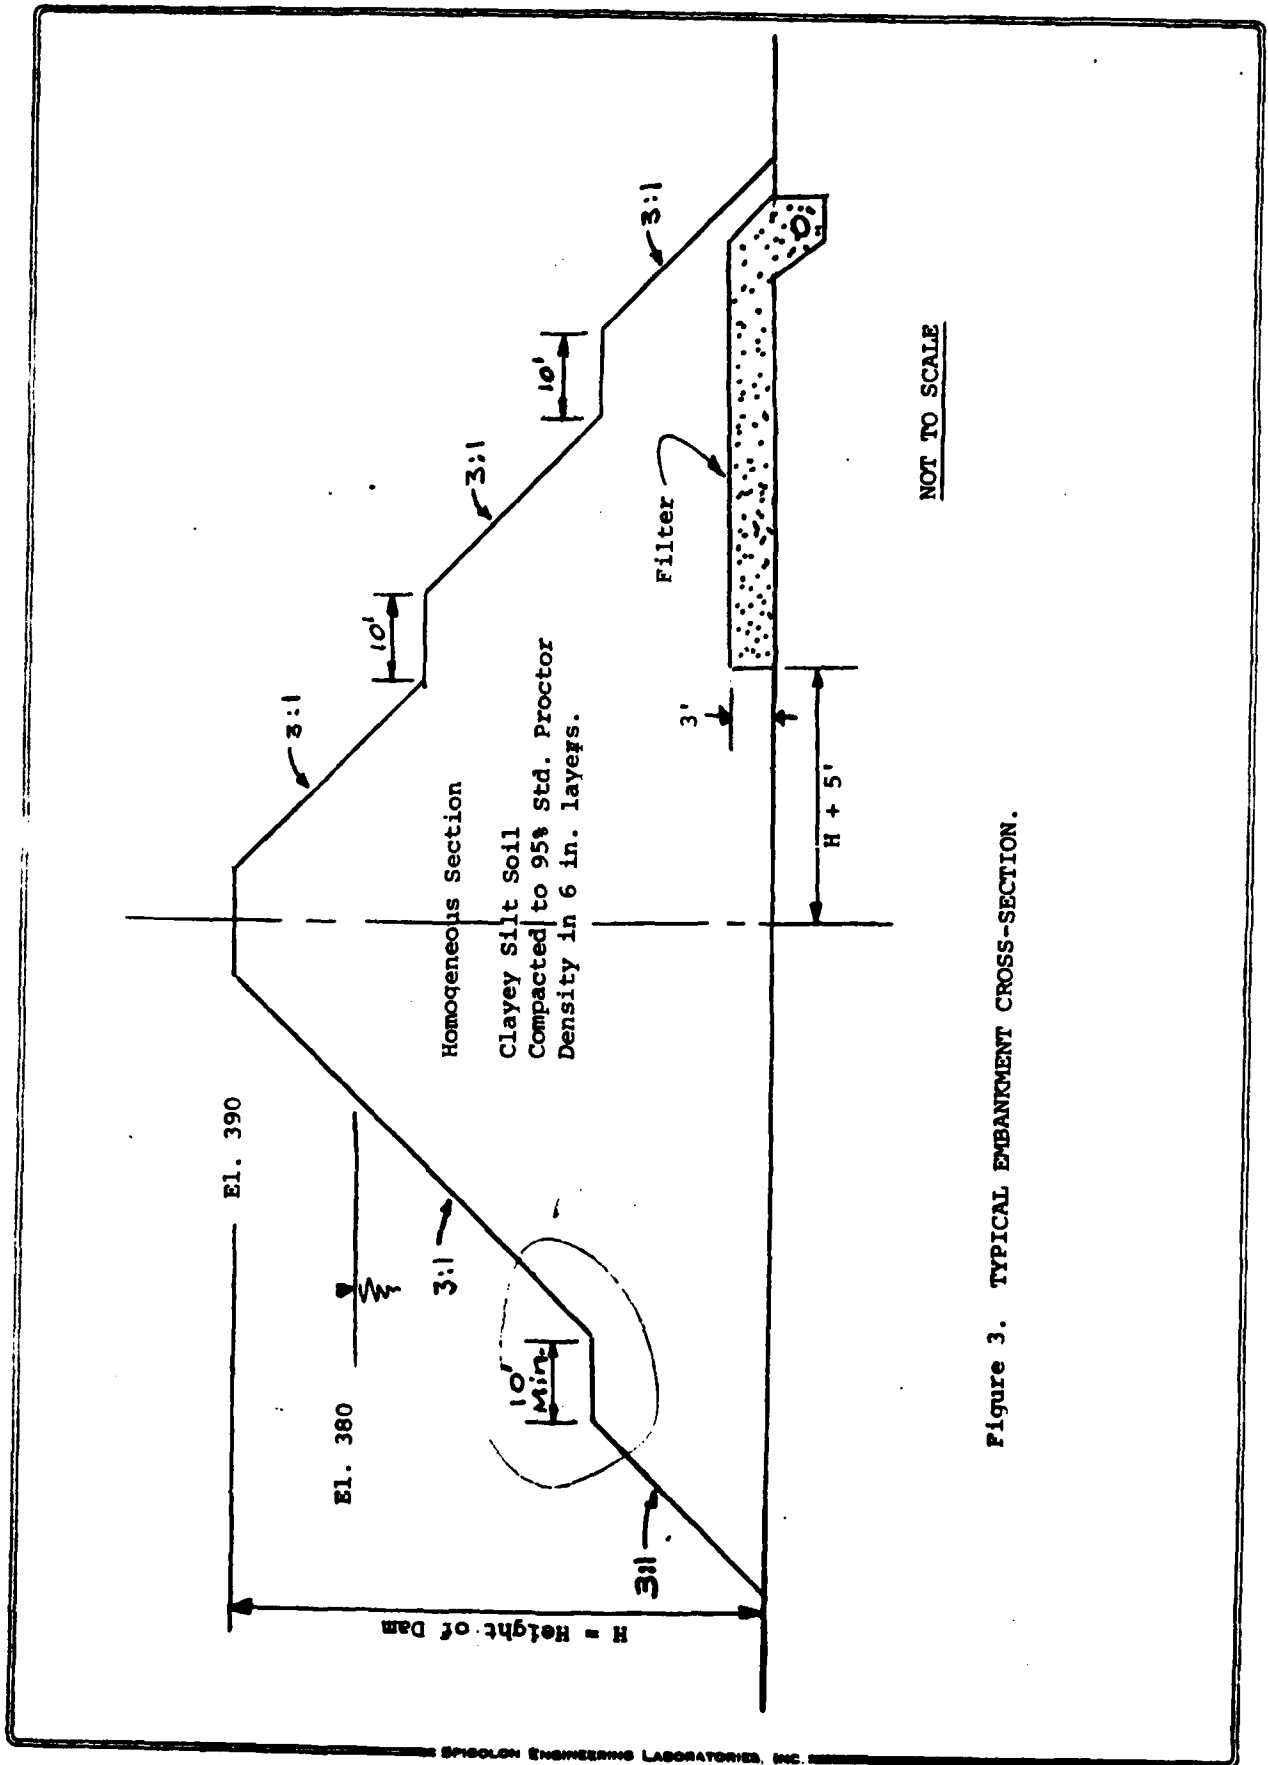
Figure 3. TYPICAL EMBANKMENT CROSS-SECTION.

A recommended embankment design cross-section is shown on the enclosed Fig. 3. A modified-homogeneous section, composed entirely of compacted loessial fill, with a blanket toe drain, and without a cutoff trench, is dictated by (a) the character of the soils in the proposed emergency spillway excavation, and (b) the presence of a ten foot thick silt blanket in the valley bottom overlying a previous substratum. Assuming a 36 foot head and a conservative value for vertical permeability of the silt, the seepage loss at the deepest part of the reservoir by downward seepage through the silt will be on the order of 0.1 cubic feet per day per square foot of surface. As will be described later, this quantity can be decreased slightly

- (F) The most secure solution is to install pressure relief trenches now, as a precaution whether they are absolutely necessary or not. The present cost will not be great.
- (G) Referring to Figure 3 of our November 30 report, a relief trench may be installed as part of the toe drain system. At the extreme downstream end of the drain, extend the lowered portion that contains the drain pipe downward to a depth of about 14 ft. to completely intercept the pervious layer. The trench need not be over about three ft. wide and only extend over the central two-thirds of the length of the dam. The same drain material used for the toe drain should be used. The drain pipe may be placed at any convenient depth, from bottom of trench to a few feet from ground surface. It should, of course, drain downstream into the existing stream bed.
